# Manhole Inspection Summary

Manhole # S19Y\_\_024MH

Insp Date: **6/2/08 10:58 AM**

**Location** Address: **1901 griffis av**

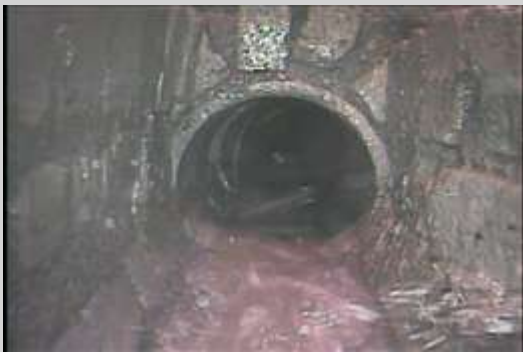
12 O'Clock Outflow

Pipe Height: **8.4** (in.) Rod and Bar (Angled)  
Pipe Material: **Clay** ☐ Pipe Lined  
Invert Depth: **9.40** (ft.) Flow Characteristics: **Slow**  
Deposits: ☒ None ☐ Mud ☐ Sludge ☐ Debris ☐ Grease  
Silt Depth: **0** (in.) Deposits Extent:  
Infiltration: **None** Pipe Seal Cond: **Sound**

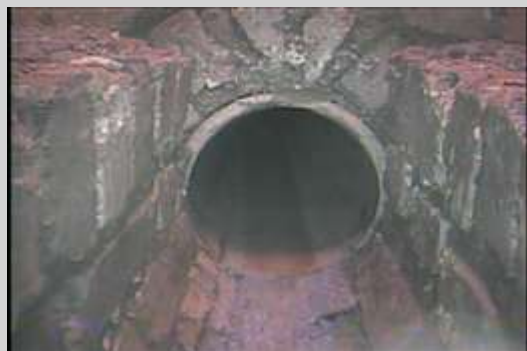
6 O'Clock Inflow

Infiltration: **None** Pipe Seal Cond: **Sound**
